## **Dust or Gas Explosion: Case Study of Dryer Explosion and Design Venting**

**Scott G. Davis**  
GexCon US  
7735 Old Georgetown Rd., Suite 1010  
Bethesda, MD 20814  
[sgdavis@gexcon.com](mailto:sgdavis@gexcon.com)

Prepared for Presentation at  
American Institute of Chemical Engineers  
2010 Spring Meeting  
6th Global Congress on Process Safety  
San Antonio, Texas  
March 22-24, 2010

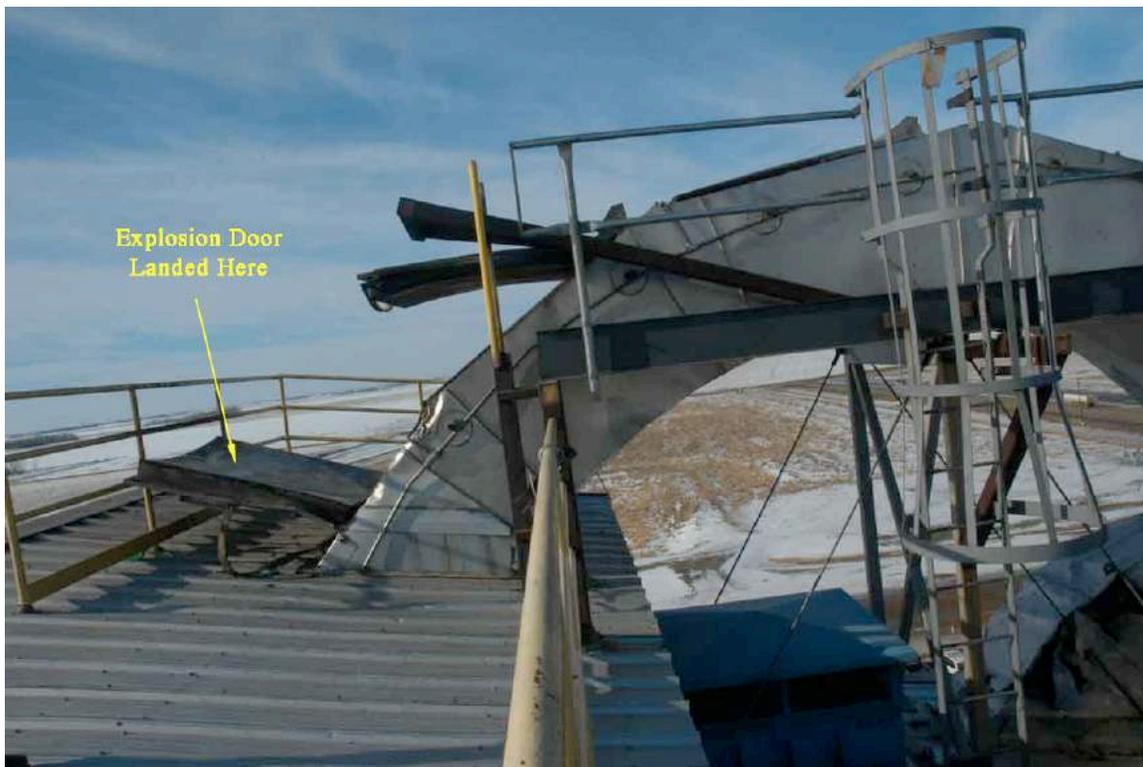
GexCon engineers were retained to investigate an explosion that occurred at approximately 3:16 am in a process facility. The explosion occurred in one of two single burner, recirculating solids ring dryers. No one was reported injured as a result of the explosion, however the explosion caused significant damage to the dryer and minor damage to sections of the facility. No one was reported injured as a result of the explosion. All four of the explosion panels on the external ring duct, the two explosion panels on the dryer cyclone header, and the pre-separator explosion panel had opened during the explosion. For the purpose of this study, hinged explosion doors and panels are used interchangeably. In addition, a manual entry door into the hot air box was blown open during the explosion. Two of the explosion panels P1 & P2 (discussed later) on the external ring duct were separated from their hinges, with one landing on the upper roof section next to explosion panel P4 (see Figure 1), while the other panel fell back through the roof of the facility (see Figure 2).

**Figure 1: Explosion panel (door) from external ring duct that landed on the upper roof**

2. The designer of the dryer should have provided a sufficient means of securing the explosion doors on the ring dryers and failed to meet the requirements of NFPA 68 *Guide for Venting of Deflagrations*, which states, “For personnel safety, the door or panel should be designed to remain intact and to stay attached.”

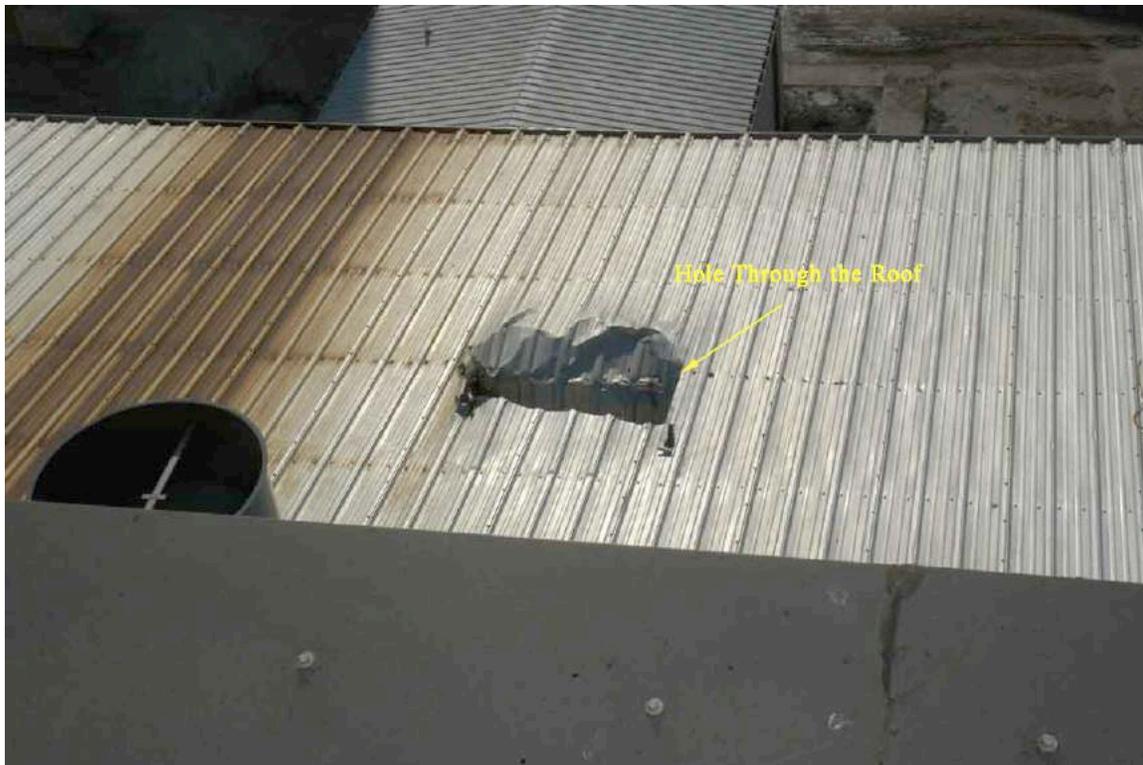
**Figure 2: Explosion panel (door) that penetrated the roof**

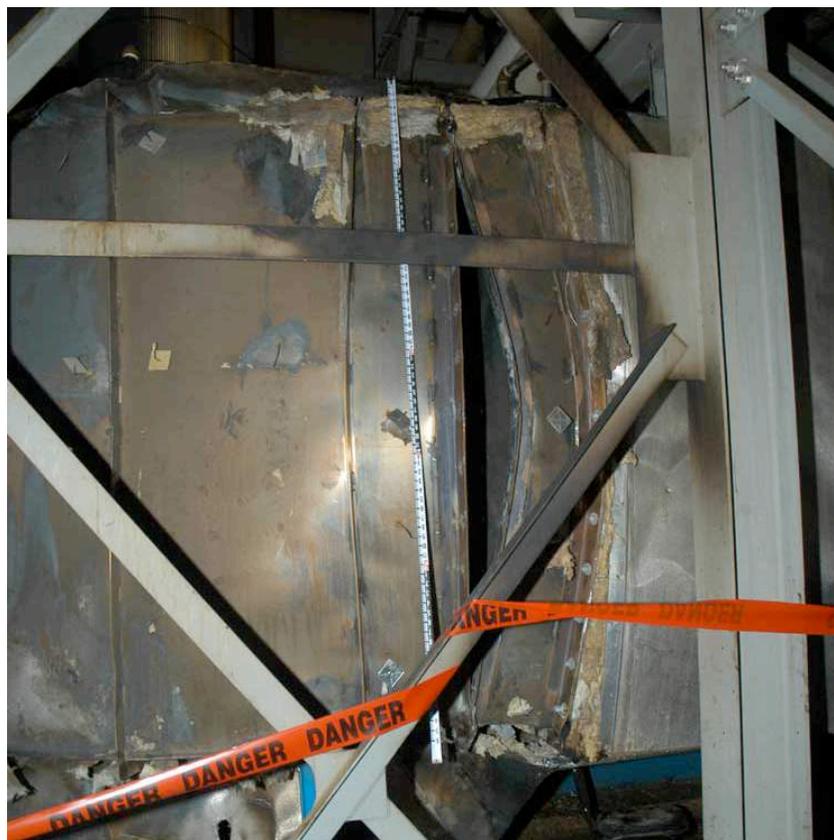
The explosion also caused a section of the recycle duct to rupture near the 90° turn, which can be seen in Figure 3. Plant personnel heard one large “boom” followed by multiple smaller explosions.

**Figure 3: Ruptured section of the recycle duct**

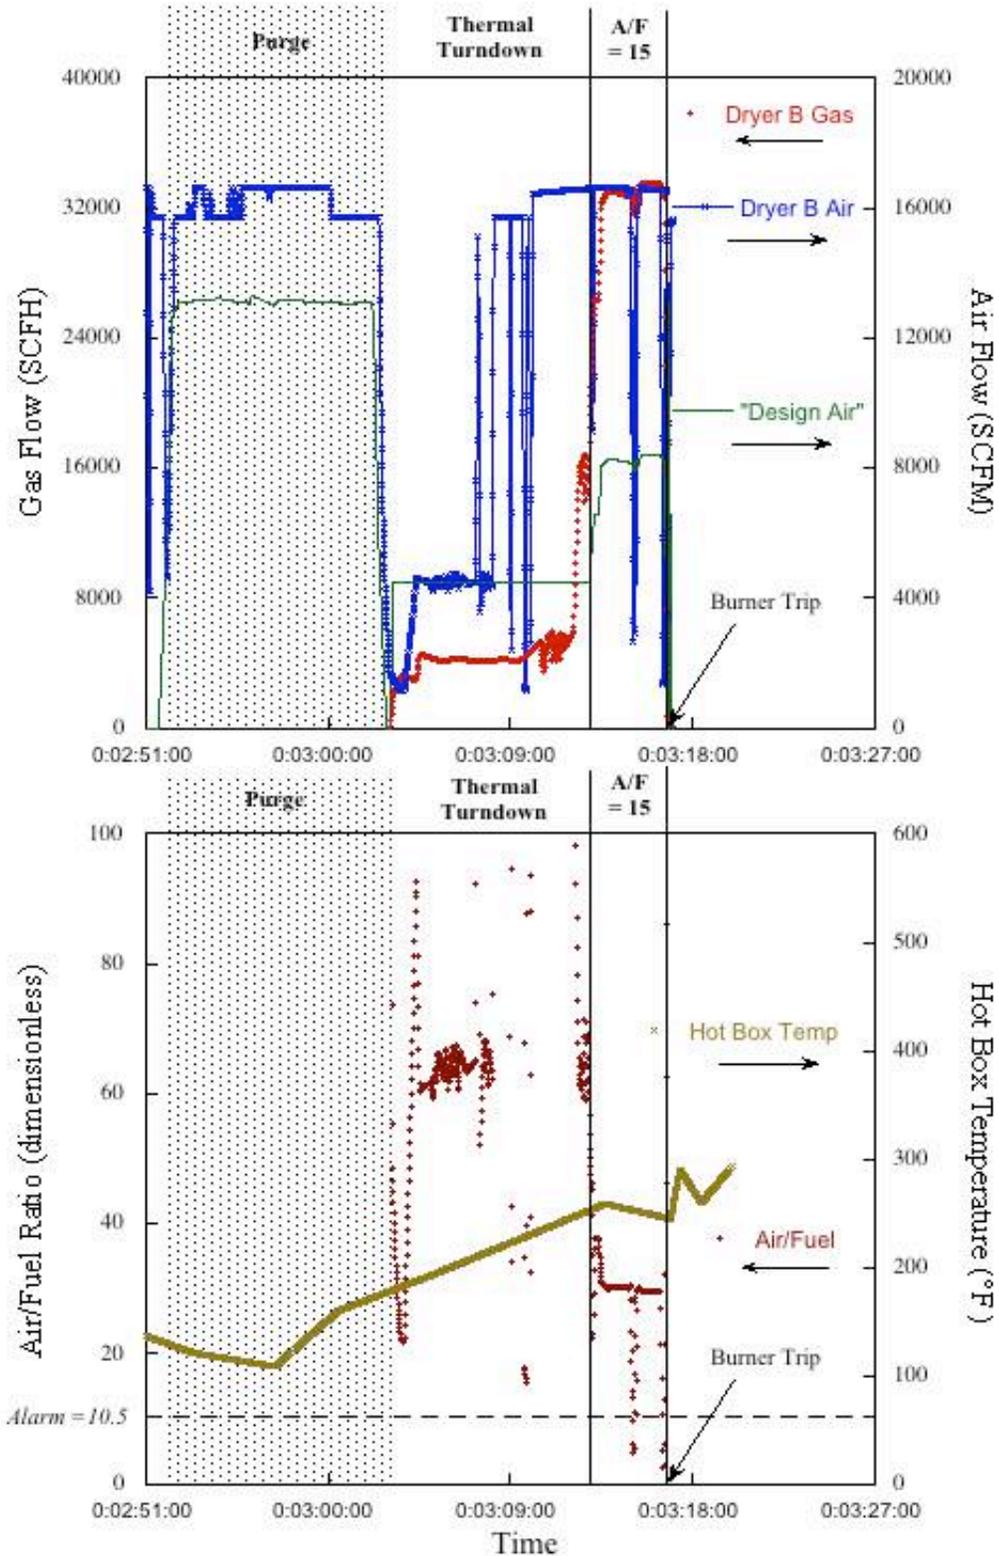
The burner on the dryer was put into purge at approximately 2:51 am, 5 to 6 minutes following a previous burner trip and approximately 25 minutes prior to the explosion. Figure 7 shows several process variables (gas flow rate, combustion air flow rate, hot box temperature and air/fuel ratio) during this particular relight of the burner in Dryer B. Also shown in the top graph of Figure 7 is “Design Air” which is a calculated combustion airflow rate that should have been present during the relight and will be discussed below.

**Figure 7: Process data for the 2:51 am relight on the day of the incident**

The process data suggests that the mass flow meter continued to fail for about 4 minutes until the burner tripped at approximately 3:16 am. The mass flow meter was not continuously in the

failure mode and would occasionally transmit the actual signal. The ratio controller has a programmed over-range alarm programmed into the unit. The over-range alarm was set to activate at signal equal to or greater than 23.5 mA. However, during the failure mode of the mass flow meter during this particular relight, it transmitted signals at approximately 21.7 mA (less than 23.5 mA). When receiving this signal, the response of the ratio controller was to drive the combustion air damper to the closed position in an attempt to maintain the pre-determined air/fuel ratio set point.

- a. On the dryers that use the incident flow meter for combustion air and the incident air-to-fuel ratio controller, the internal jumper pins for the Failure Mode Alarm on the mass flow meter should be set to the low position for combustion air (output signal driven below 3.75 mA). In the event the ratio controller interpreted this as an actual signal, it would drive the air damper fully open causing fuel-lean conditions to exist in the dryer.

- b. The over/under range signals emitted from the mass flow meters need to be detected by the combustion management system and initiate a burner shutdown.

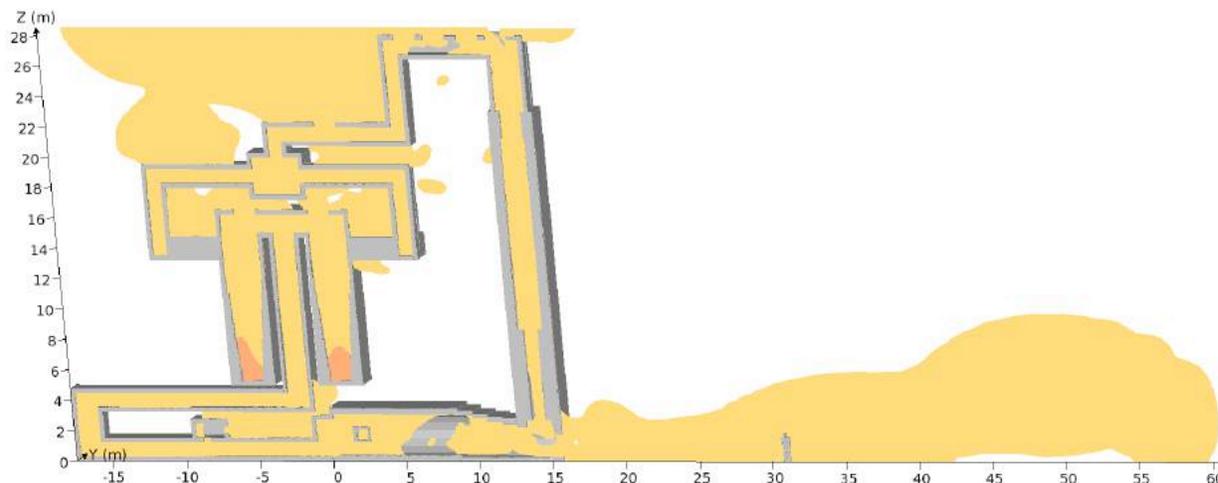
The incident caused significant damage and created numerous hazards. Some notable events included the failure of two explosion panels that became massive projectiles and the hot air box door blowing open and venting flames/hot combustion products into the facility. Explosion vents are to be located or retained so that personnel are not exposed to injury by operation of the vents. If the access door to the hot box is to be used as an explosion vent in the current configuration, personnel in front of the opening could be exposed to venting products of combustion and flames (see Figure 15).

**Figure 15: Venting of products of combustion and flames during a dust deflagration via the access door in the hot box. Note the representative employee at 31 m.**

3. The door to the hot box should be vented outside the facility, in the event it blows open during the venting of a dryer deflagration. This access door failed to meet the requirements of NFPA 86 *Ovens and Dryers*, which states, “Explosion-relief vents shall be located or retained so that personnel are not exposed to injury by operation of the vents.” While the door to the hot box may not have originally been considered an explosion vent, it can however serve such a purpose and safety design needs to be considered.
