## **Dust or Gas Explosion: Case Study of Dryer Explosion and Design Venting**

**Scott G. Davis**  
GexCon US  
7735 Old Georgetown Rd., Suite 1010  
Bethesda, MD 20814  
[sgdavis@gexcon.com](mailto:sgdavis@gexcon.com)

Prepared for Presentation at  
American Institute of Chemical Engineers  
2010 Spring Meeting  
6th Global Congress on Process Safety  
San Antonio, Texas  
March 22-24, 2010

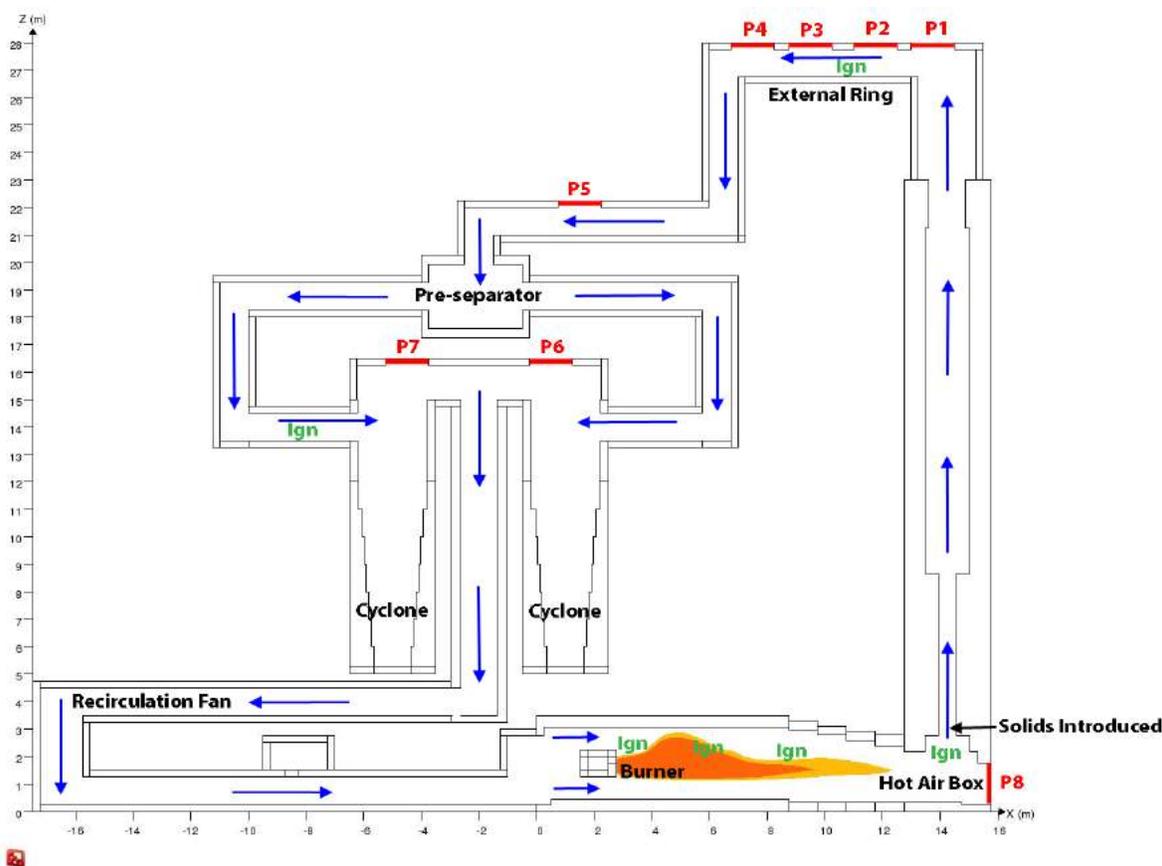
Figure 4 presents a general schematic of the dryer at the facility. The dryer consisted of a natural gas fired burner around which the recirculating flow passed. The combined combustion products of the burner and recirculating flow mixed in the horizontal section of the ductwork and turned 90 degrees vertically at the hot air box. Solid material is added just above the hot air box and the material is conveyed up to the external ring section of the dryer, which has four hinged explosion panels installed on in this section of the duct (P1-P4). Downstream from the external ring, the material flows to a pre-separator, which removes some of the high moisture content material and re-introduces it into the hot box, and has an explosion panel installed (P5). After the pre-separator, the dried material is removed via the two cyclones (with two explosion doors P6, P7) and the remaining gases are circulated back to the burner. There was another door (P8) provided at the hot box to provide access for cleaning and removing accumulated solid material.

Figure 4: Schematic of facility solids dryer

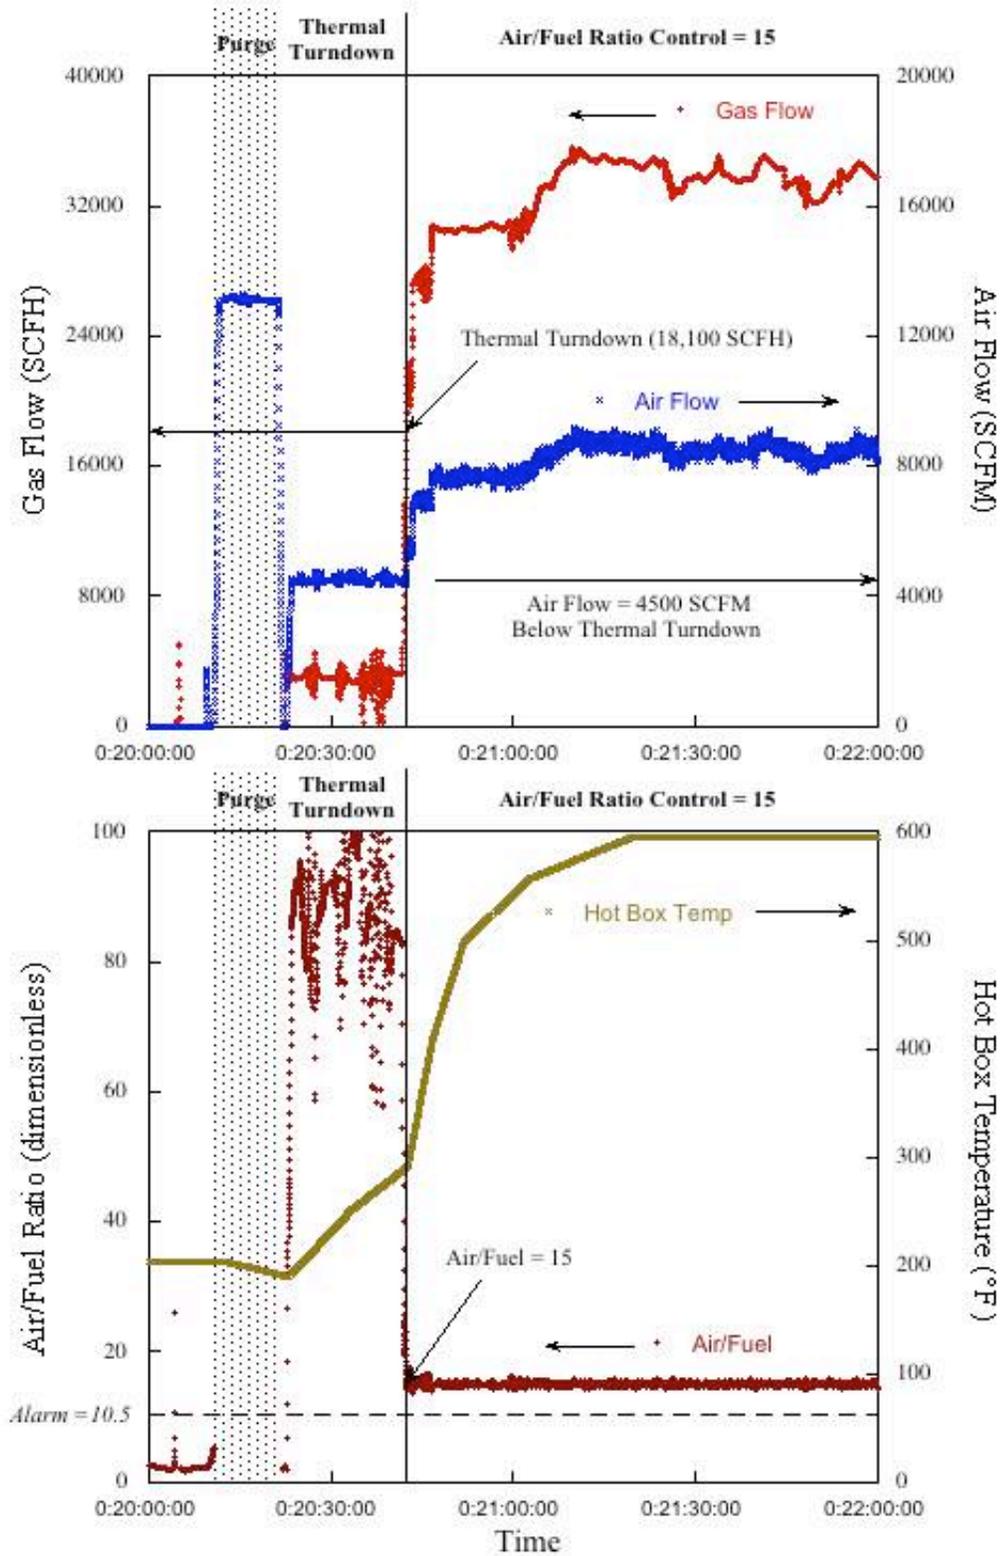
Figure 6 shows several process variables (gas flow rate, combustion air flow rate, hot box temperature and air/fuel ratio) during a typical relight of the burner in Dryer B. The system is configured for a 10-minute purge period, where the combustion damper is driven to the fully open position and the gas valves are closed, as shown in the shaded areas in Figure 6. The burner is initially relit in a low-fire mode (thermal turndown), where it is maintained for 20 minutes.

After this warm-up period the gas flow rate was increased and product was added to the dryer. As the gas flow rate increased past 18,100 SCFH, the combustion airflow was proportionally controlled to the air/fuel ratio of 15/1. This ratio was maintained fairly steadily while the hot box gradually reached its typical operating temperature of approximately 600 °F. Also shown in Figure 6, is the ratio controller alarm that was specified to activate when the air/fuel ratio drops below a ratio of 10.5/1. To avoid nuisance trips, the air/fuel ratio must remain below this set point for 4 seconds to activate the alarm.

Figure 6: Process data for a typical relight of the dryer

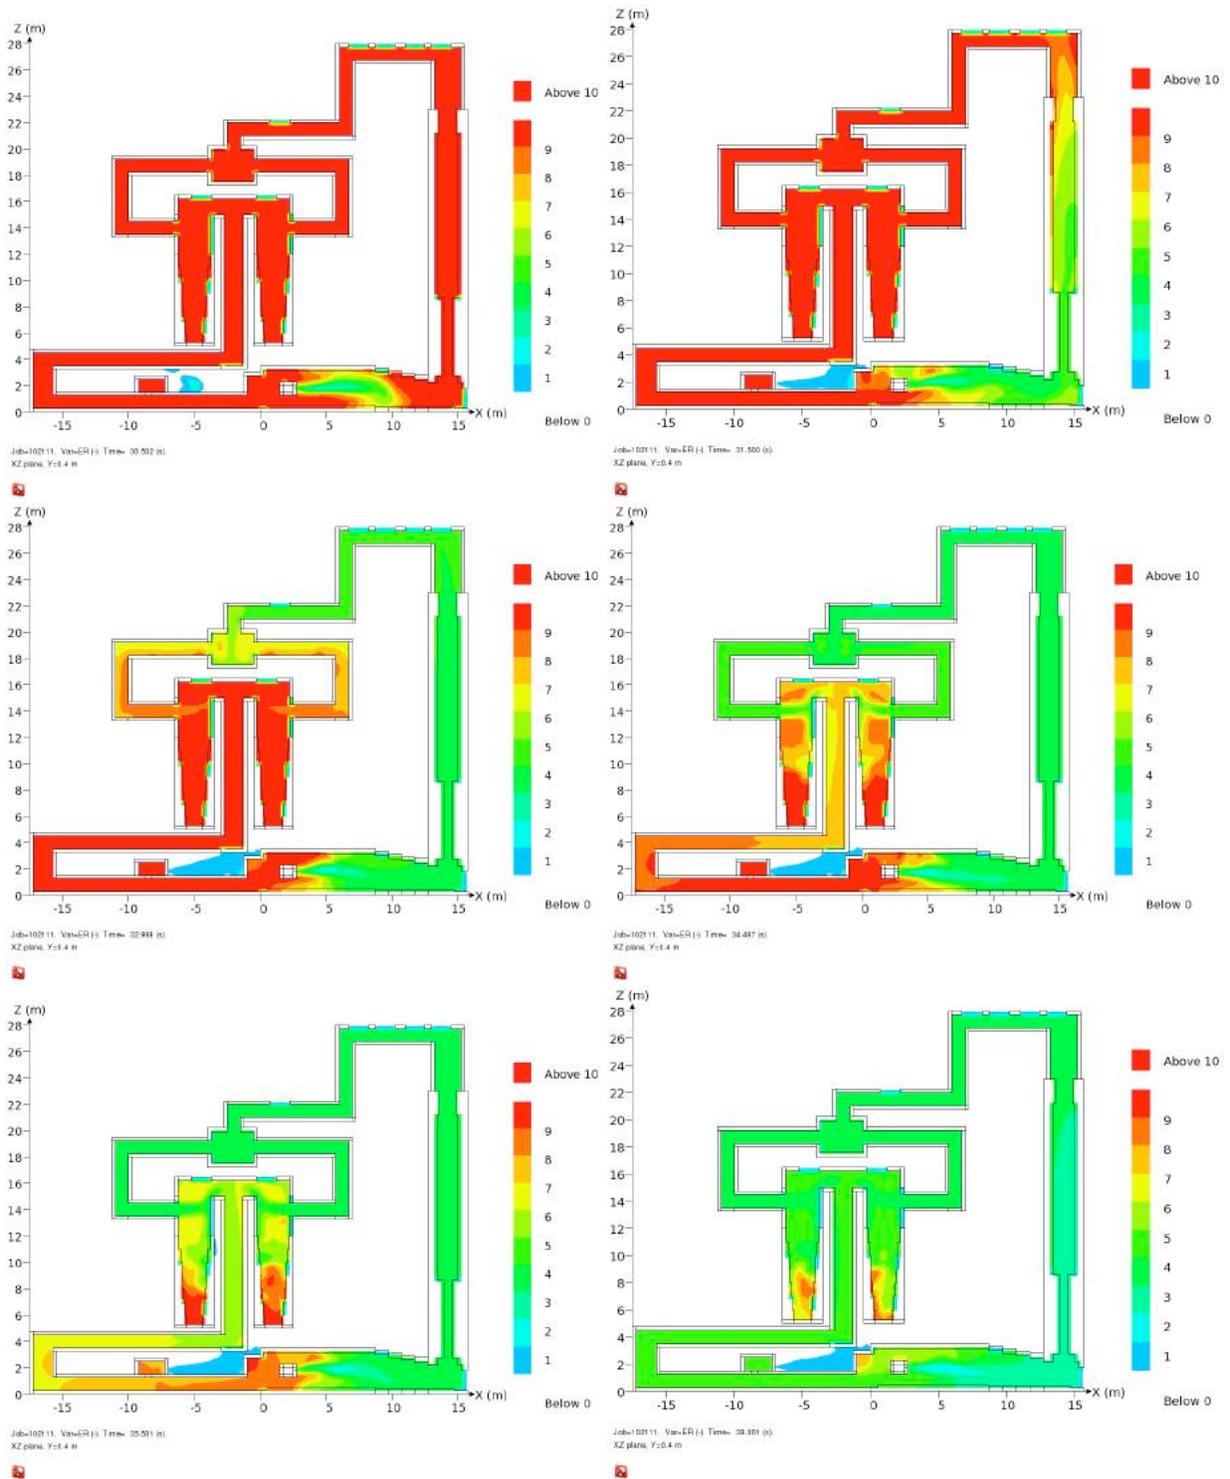
In Figure 8 the development of the gas mixture during the 8-second air purge is shown. Initially the whole system is filled with a fuel-rich composition with approximately 10 times more fuel than optimum for combustion. The gas mixture, with large fractions of hydrogen and CO, is estimated to be flammable at equivalence ratios (ER) from 0.5 (the lower flammability limit – LFL) to 4.7 (the upper flammability limit – UFL). The highest burning velocity is estimated to occur at ER=1.5. For concentrations near the flammability limits (e.g. ER above 3.5) one can expect quite slow, if any, flame propagation, which will likely be dominated by the strong circulation flow of the dryer system. The high turbulence levels within the dryer may also prevent ignition of such weakly burning mixtures. As the air purge continues, the equivalence

As the air purge at the burner is initiated, the simulation results shows a small air pocket downstream of the burner that quickly gets diluted to non-flammable or barely flammable concentrations. Once this barely flammable plug of gas (that has the additional air from the purge) has circulated one loop in the system and starts receiving air injected from the purge for the second time, a much more reactive pocket of flammable fuel-air is formed. Both from process data and the simulation results, it can be seen that it takes approximately 6 seconds for the flow within the dryer to complete one loop in the system. The simulations show that the highly flammable pocket of fuel-air grows rapidly after 6 seconds. The explosion takes place approximately 8 seconds after the air purge at the burner is started. However, if ignition had been further delayed to say 10 seconds, a much larger flammable gas cloud would have been present and a much stronger explosion could have occurred. In Figure 9 the development of the flammable cloud downstream of the burner air purge is shown for the studied ignition locations.

**Figure 8: Simulated fuel-air ratio (equivalence ratio) in system during 8 seconds of air purging (starting at time=30s). The estimated flammable range for the actual mixture is from ER=0.5 (LFL) to ER=4.7 (UFL)**

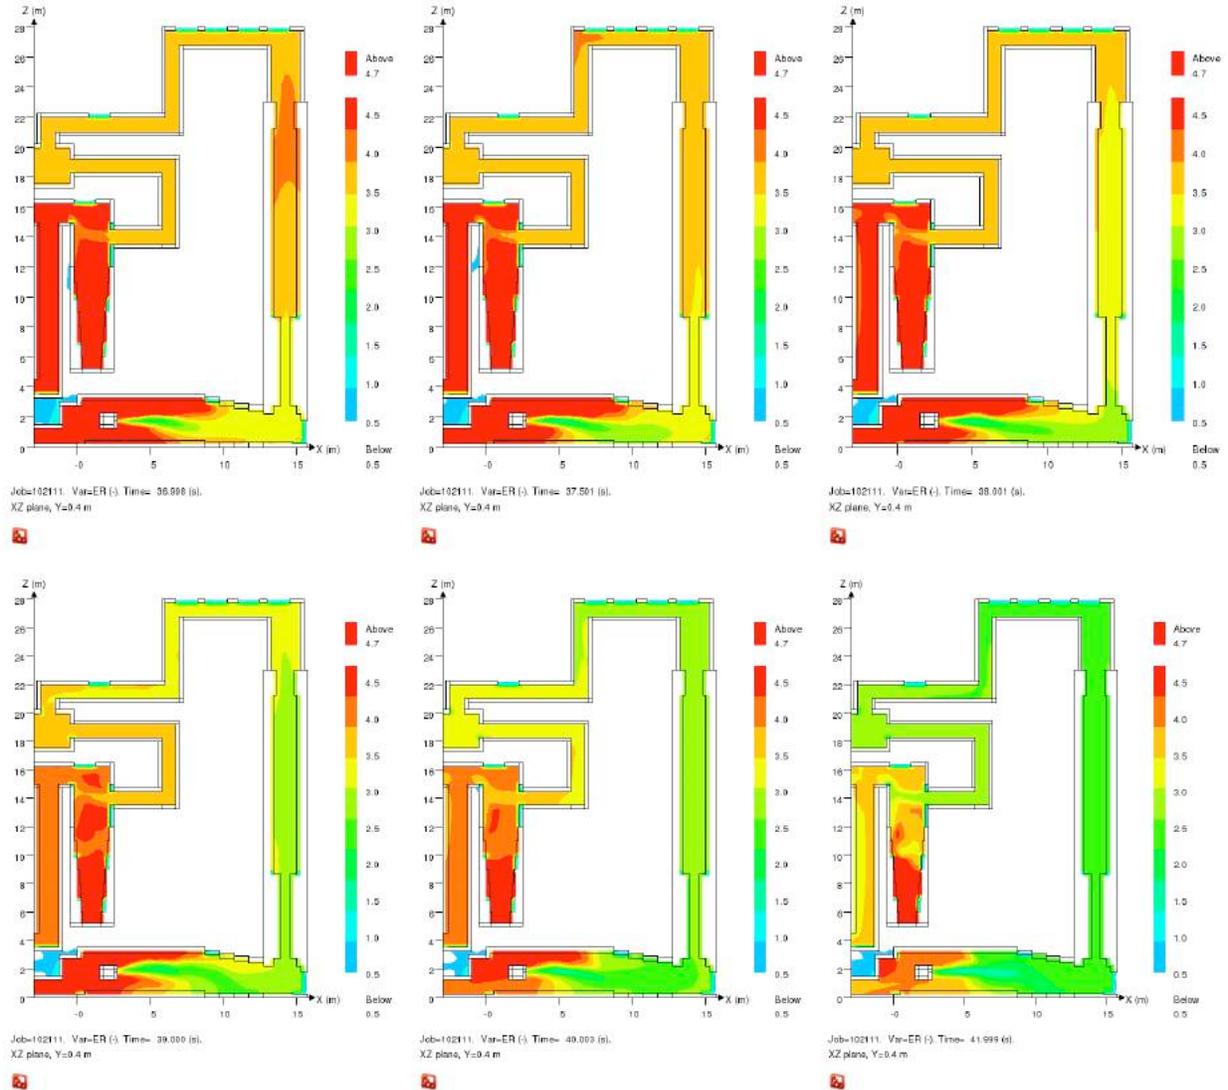
There are some uncertain parameters in the present work, yet the ignition appears to have occurred approximately 7.5 to 8.0 seconds after the burner air purge was initiated. While the ignition location is in the region downstream of the burner, its exact location is not known. In addition, small deviations exist in our modeled dryer (e.g., definition of bends) and there are uncertainties associated with the exact composition of the gases circulating within the dryer. Therefore, we also evaluated small deviations in ignition time compared to observed times. More specifically, we evaluated a few different ignition locations and ignition times to see if ignition scenarios can be determined that partly or fully explain the observed damage level and sequence of explosion panel opening. One additional parameter that is not known is the opening characteristics for the access door in the hot box (P8). If this door is stronger than the vent panels this can have a significant effect on explosion pressures since the door is very close to the assumed gas cloud location and ignition. For most cases, this door has been assumed to have the same strength as the explosion panels (50 mbar), but sensitivity calculations have been performed with a higher opening pressure (100 mbar).

**Figure 9: Gas cloud concentrations downstream of air purge location at different studied ignition times, 7s, 7.5s, 8.0s, 9.0s, 10s and 12s. The estimated flammable range for the actual mixture is from ER=0.5 (LFL) to ER=4.7 (UFL)**

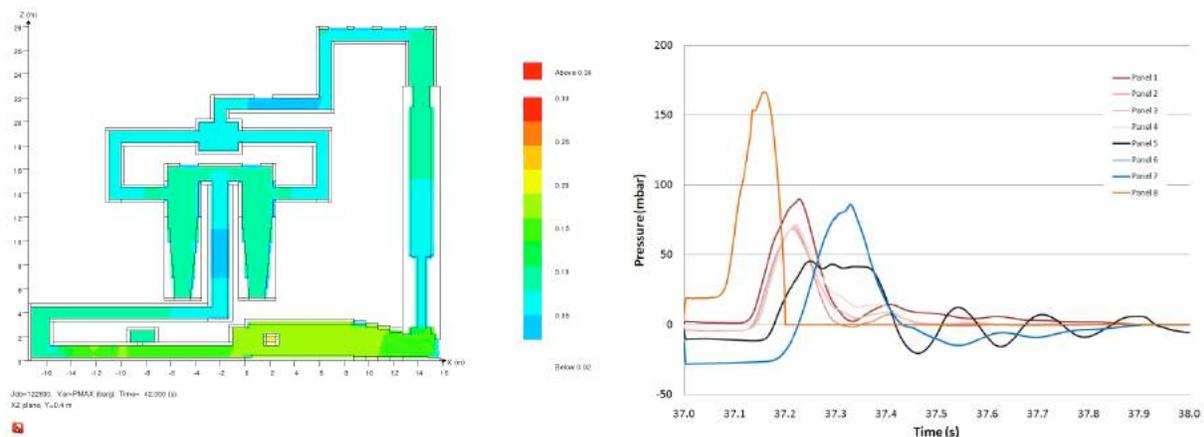
All the scenarios with ignition at 7.0 seconds within 2.5m of the burner can replicate many of the characteristics of the explosion. Panels 1-4 (red in the panel pressure plots) and 6-7 (blue), in addition to the hot box access door (orange), opened, whereas panel 5 (black) in general did not yield for these scenarios. There is however a 100ms time delay from the opening of panels 1-4 to the opening of panels 6-7 (these were reported to have near-simultaneous opening times in the incident). The exact resolution for the recorded event log is unknown and this scenario may be close to the actual opening times. For all these scenarios the pressure level is around or slightly above the required design strength as recommended by NFPA 68. However, we do not have sufficient knowledge about the actual design strength to judge whether these pressure loads may explain the observed damage to the dryer. The ignition located 5m downstream from the burner also shows many characteristics similar to those observed in the previous case, except that panel 5 yielded within 90ms of panel P1. This scenario may be consistent with the explosion panel switch being “stuck” and not properly recording the opening of P5.

**Figure 10: Explosion scenario with ignition at 7s (ignition position is 2.5m downstream of burner and door opening pressure 100 mbar). The left picture shows the distribution of maximum pressure seen in the system during the explosions, whereas the right picture shows the recorded explosion panel pressures.**

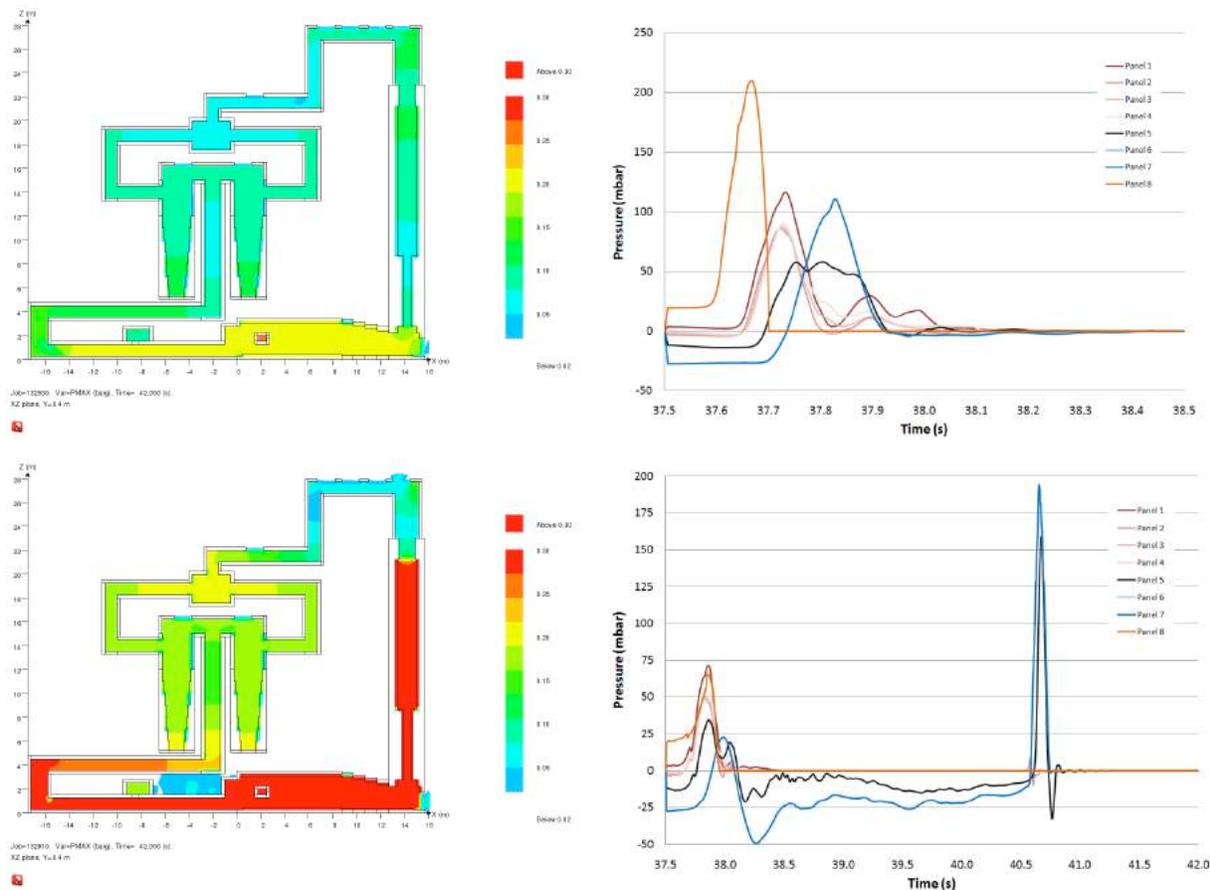
Seven different ignition scenarios with ignition at 7.5 seconds were simulated. Two of these cases are shown in Figure 11. In general, very similar trends as those reported for the 7.0-second ignition time are observed, except that pressure levels are slightly higher. This may be more realistic with regard to the observed damage to the duct upstream of the burner, however, due to the increasing pressure, panel 5 starts opening at times very close to panels 1-4. The first scenario shown in Figure 11 is one example of this group of scenarios.

At one ignition location for the 7.5-second ignition case, panel 5 did not open with panels 1-4 but opened 3 seconds later consistent to what was recorded in the process data. This scenario is with the ignition in the bend downstream from the hot box and this case is shown in Figure 11. Here it can be seen that panels 1-4 and the access door (P8) open early, and that panels 5, 6 and 7 open violently 3 seconds later. In the actual explosion only panel 5 opened with a delay at the same time an explosion panel for the cyclone closed. Therefore this scenario has been ruled out as it does not properly reconcile the sequence of events and includes a potentially unrealistic ignition source remote from the burner.

**Figure 11: Two explosion scenarios with ignition at 7.5s. The left pictures show the distribution of maximum pressure seen in the system during the explosions, whereas the right pictures show the recorded explosion panel pressures. The upper plot is for ignition 2.5m downstream of burner and door opening pressure 100 mbar, whereas the lower plot is for ignition just downstream of the hot box with door opening pressure 50 mbar.**

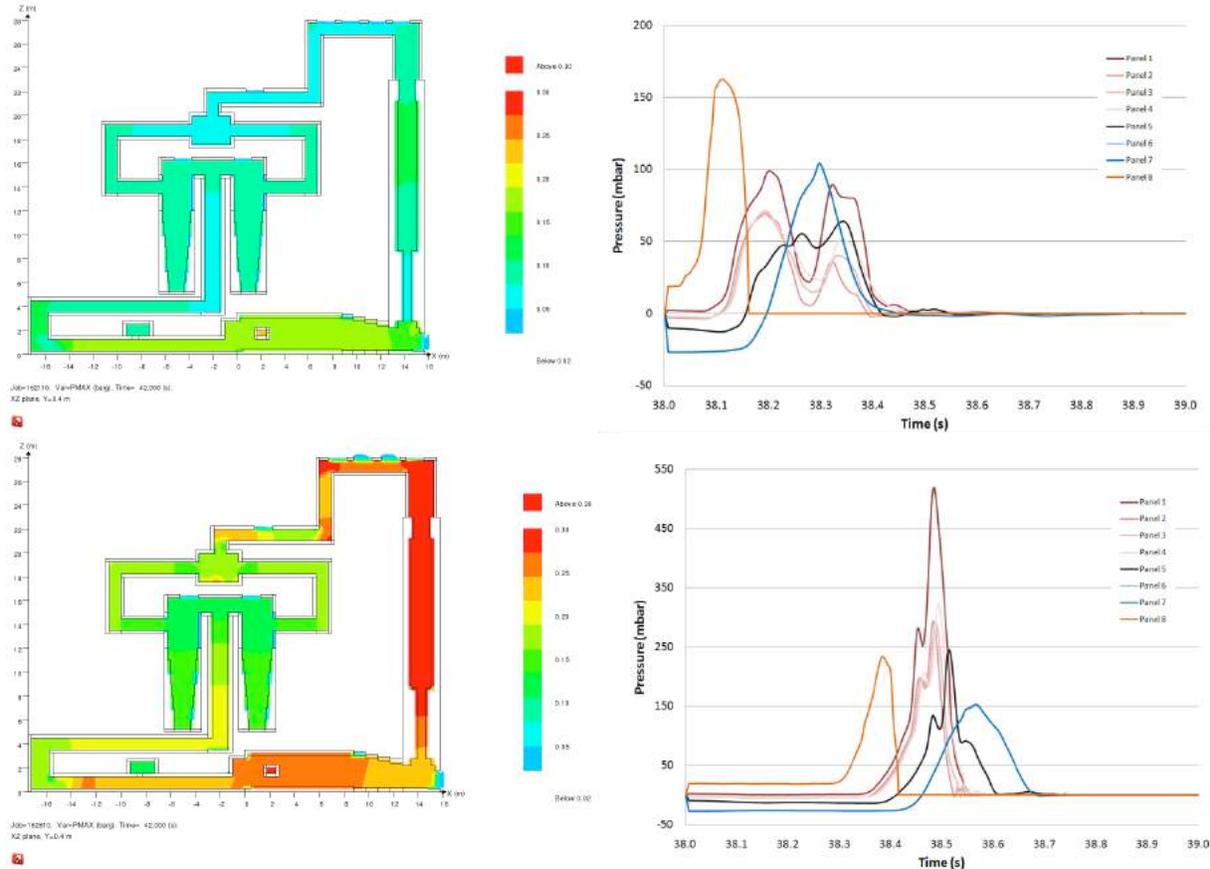
Three different scenarios with ignition at 8.0s were simulated. Two of these cases are shown in Figure 12. For ignition near the burner, similar trends as seen with the 7.0- and 7.5-second ignition cases were observed, which can be seen in the upper plots of Figure 12. Explosion pressures increase considerably if the ignition location is moved further downstream of the burner, where the pressure distribution for ignition located 5m downstream of burner is shown in the lower plot of Figure 12. High pressures reach panels 1-4, and these could help explain that

the hinges of panel 1 broke and made the panel into a projectile during the explosion. For scenarios with an even more delayed ignition, the flammable gas cloud at the time of ignition is larger and more severe explosions are observed. These severe explosions are not consistent with the observed damage.

**Figure 12: Two explosion scenarios with ignition at 8.0s. The left pictures show the distribution of maximum pressure seen in the system during the explosions, whereas the right pictures show the recorded explosion panel pressures. The upper plots are for ignition near the burner, whereas the lower plots are for ignition 5m downstream of the burner (door opening pressure is 50 mbar in both cases).**

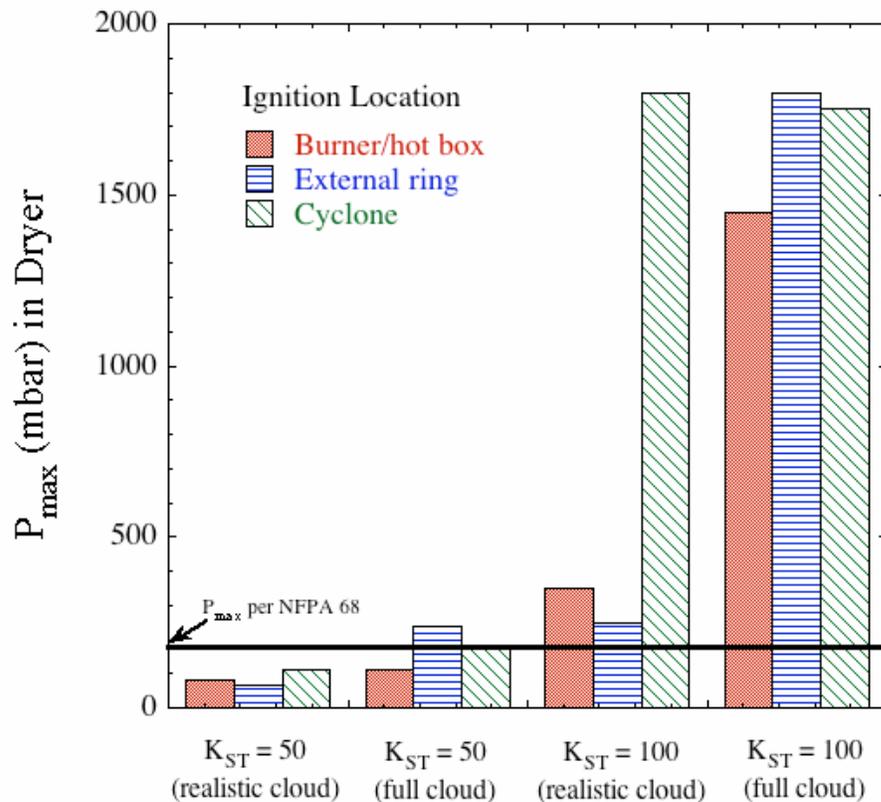
In Figure 13 the maximum pressures observed in the dryer are reported for all simulated dust explosion scenarios for an initial temperature of 120°C. Provided the NFPA 68 recommendations on system strength are followed (system should withstand 2.5 psi), the simulations predicted that the system should generally be well designed to resist dust explosions for dusts with a  $K_{ST}$  of 50 bar-m/s, which is double the reactivity reported for the actual dust. The dust cloud sizes and conditions were overly conservative (filling the whole dryer with worst-case reactivity dust).

In Figure 13 it can also be seen that if the dust reactivity is doubled ( $K_{ST} = 100$  bar-m/s), the explosion pressures are predicted to increase almost one order of magnitude for some scenarios.

**Figure 13: Overview of overpressures obtained in simulated dust explosion scenarios at initial temperature 120°C.**

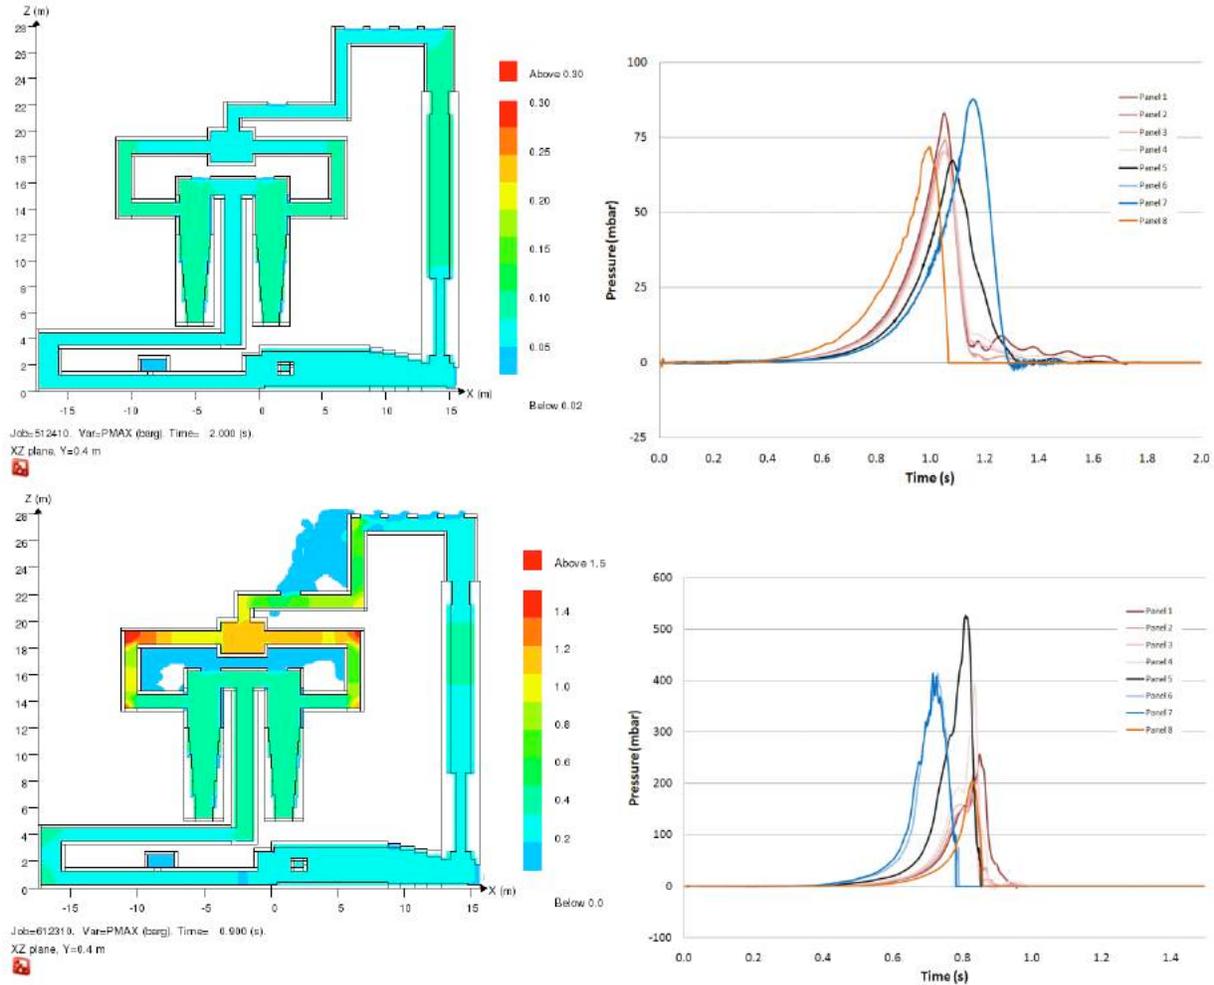
In Figure 14 some simulation results are shown, in both cases with the “realistic” flammable dust cloud assumption covering the region from the exit of the hot box to the cyclones. The initial temperature in the dryer is 120°C and a normal air atmosphere is assumed. The latter is a very conservative assumption as the process is normally oxygen starved. The first scenario is with a dust reactivity  $K_{ST}$  of 50 bar-m/s and ignition at the exit of the hot box. From the plots it can be seen that the explosion pressures are well controlled by the explosion vent panels, and the maximum pressure reported in the dryer is less than twice the panel opening pressure of 50 mbar.

The second scenario shown in Figure 14 is one of the sensitivity calculations with the significantly higher dust reactivity ( $K_{ST} = 100$  bar-m/s) and ignition near the cyclones. In this

simulation overpressures of more than 1 bar are predicted between the cyclones and explosion panel 5. Explosion panels 1-4 have a positive effect of reducing the pressure level and keeping pressures below 0.5 bar in the pipes down towards the hot box.

**Figure 14: Dust explosion scenarios with realistic dust cloud between hot box and cyclones. The upper plots show predicted explosion pressures for  $K_{ST} = 50$  bar-m/s dust with ignition near the hot box, while the lower plots show predicted pressures for  $K_{ST} = 100$  bar-m/s dust with ignition near the cyclones. Left plots are showing maximum pressure distribution in system during explosion, the right plots show vent panel pressure during explosion.**
